CORROSION OF ALUMINUM ALLOYS –
POLYMER MATRIX COMPOSITE INTERFACES IN DIVERSE NATURAL ATMOSPHERIC
ENVIRONMENTS

A THESIS SUBMITTED TO THE GRADUATE DIVISION OF THE
UNIVERSITY OF HAWAI‘I AT MĀNOA IN PARTIAL FULFILLMENT OF
THE REQUIREMENTS FOR THE DEGREE OF

MECHANICAL ENGINEERING

May 2017

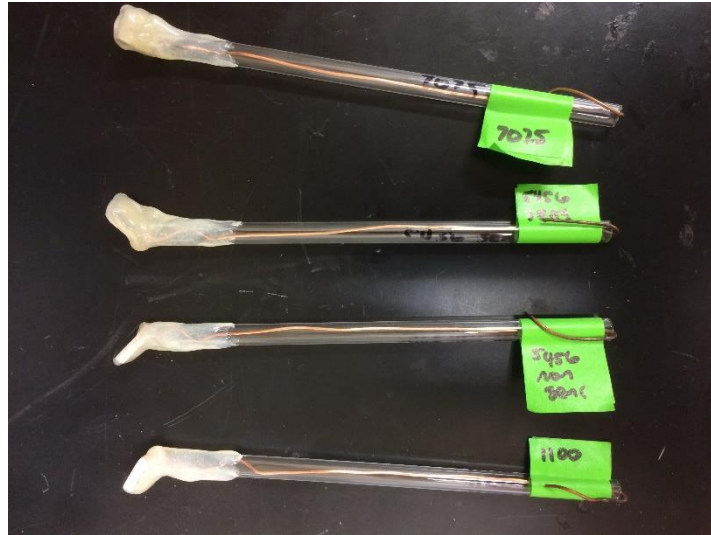
Figure 13: Polarization Experiment Samples

Figure 13 above displays the completed Al alloy polarization samples (Al 1100-H14 bottom, Al 5456-H116 (non-sensitized) second from bottom, Al 5456-H116 (sensitized) second from top, and Al 7075-T6 top).

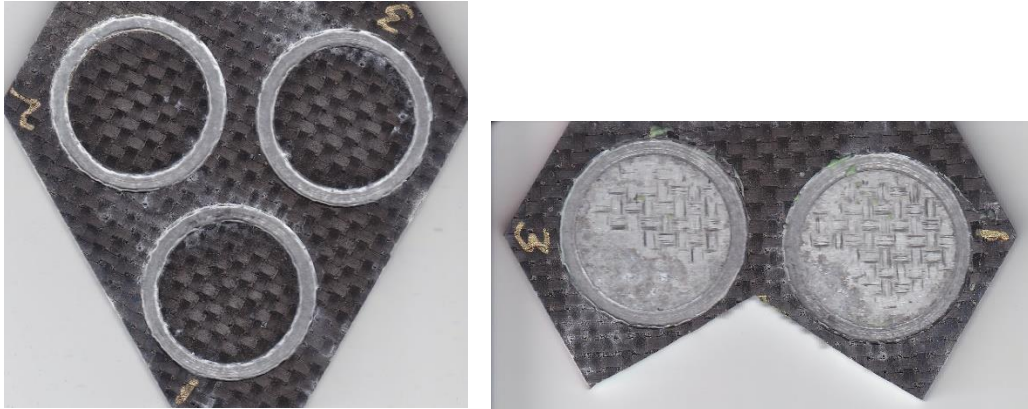
After performing the adhesion test experiment listed in section 4.4 *Adhesion Testing Experiment*, the samples were sent to the University of Hawaii machine shop where one of the test areas was cut off and the composite layer was mechanically removed (Figure 14).

Figure 14: Composite-Al Sample Before (left) & After (right) Removal of Profile Test Sample

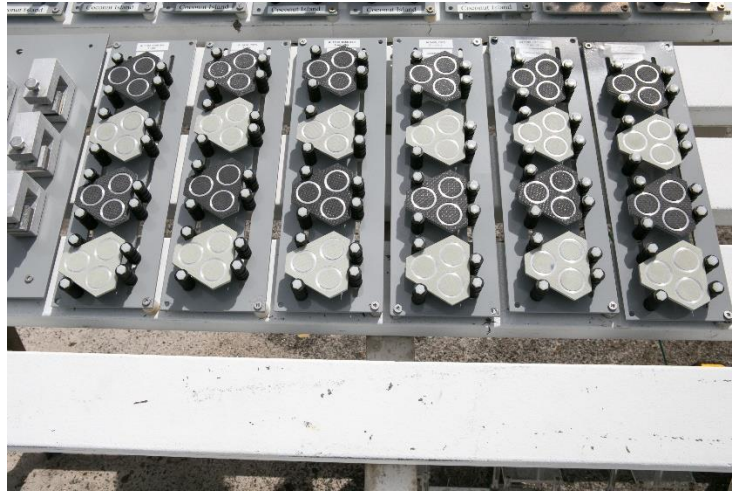
Figure 21: Typical Field Exposure Sample Layout

One test sample of each laminate (GFRP and CFRP) coupled to each alloy of aluminum (Al 1100-H14, Al 5456-H116 sensitized, Al 5456-H116 non-sensitized, and Al 7075-T6) for each of the exposure periods (1 month, 6 months, and 1 year) for a total of 24 samples were brought to each test site. The one notable exception to the exposure periods was at Pyramid Rock. The environment was so severe the CFRP laminated aluminum samples were returned to the lab at 20 days, 80 days, and 110 days in order to get meaningful data when performing the adhesion test. Another notable exception was at the Mauna Loa test site, there were no CFRP laminated Al 5456-H116 sensitized

samples for the 1 month and 6 month time period due to a shortfall in production of those samples. A typical test sample orientation at a test site is shown in Figure 21 below.

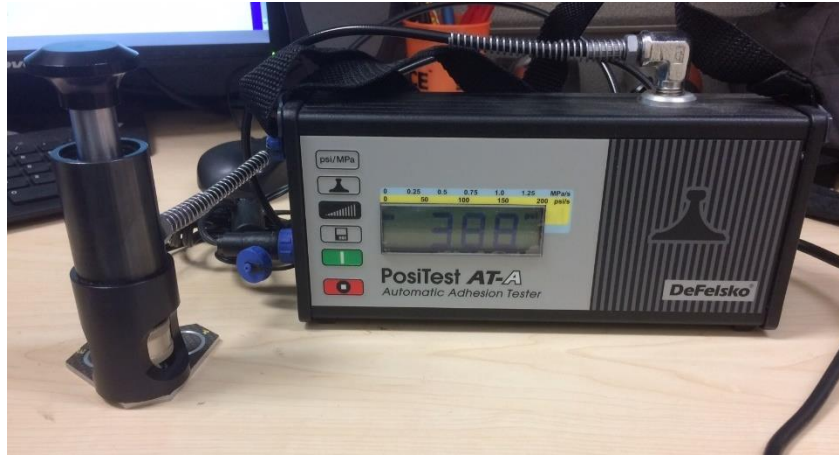
Figure 23: Composite-Laminated Aluminum Sample in Adhesion Tester

The cured and labeled samples were then put into the DelFelsko PosiTest AT-A Automatic adhesion tester, which was set to 20 mm dollies and a pull rate of 30 psi/sec. This pull rate was the slowest the adhesion tester could perform, and allowed for a more even pull and a higher success rate for

complete delamination. Figure 23 below shows how the adhesion tester was coupled to the test samples.

When the adhesion test was complete, the pressure to remove the dolly (in psig) and whether or not the test was successful in completely removing the composite from the substrate was recorded.

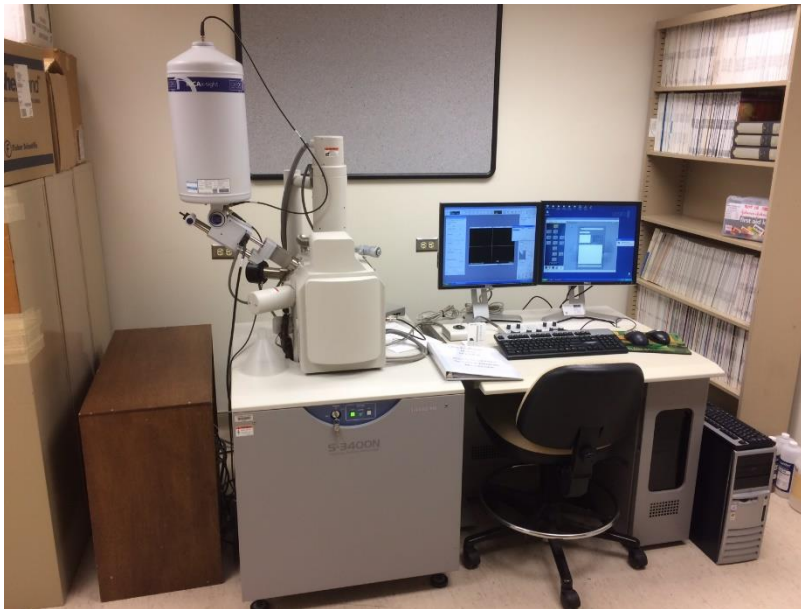
The corrosion products that formed on the substrate aluminum around and below the composite reliefs were studied with a Hitachi S3400-N scanning electron microscope equipped with an Oxford Instruments energy dispersive X-ray analyzer. Figure 25 below shows the SEM and EDX.

Figure 25: Hitachi S3400-N SEM with Oxford Instruments EDX Analyzer

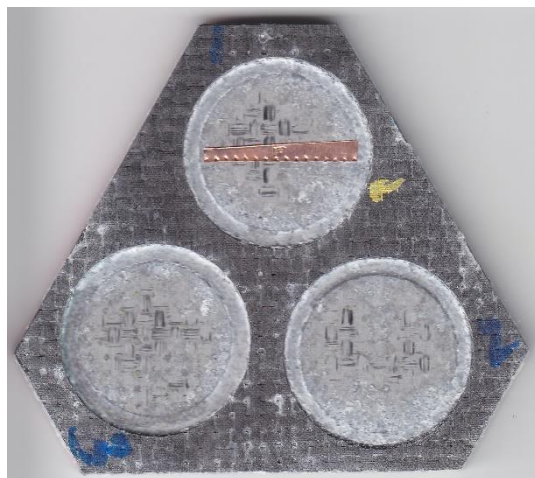
The copper strip was then marked in the center of each relief and subsequent marks were placed approximately 1 mm apart to help serve as a reference point when the sample was in the SEM (Figure 26).

Figure 26: Composite-Laminated Al Sample with Copper Strip for SEM/EDX Analysis

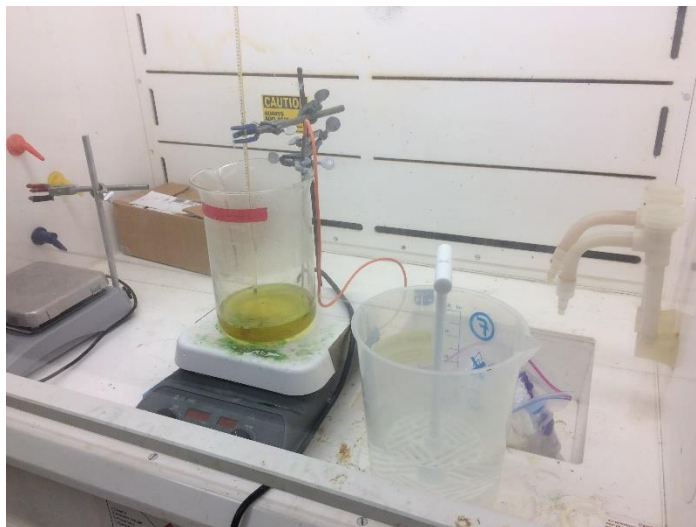
After performing the profile test listed in section 4.6 *Profilometry Analysis* above, the Mg_2Al_3 precipitates were removed from the bulk aluminum substrate in accordance with the ASTM G67-13 procedure [8]. The all dimensions of the aluminum samples are taken to within 0.02 mm and the total surface area of each sample was calculated. Each of the aluminum samples were then desmuted by submerging in a 5% by weight NaOH solution at 80° C for 1 minute, followed by an ultrapure (18 M Ω •cm) water rinse. The samples were then submerged in a 70 wt% solution of HNO_3 at 30° C for 30 seconds, followed by the ultrapure water rinse. After drying, the samples were weighed to within ± 0.0001 g, and then submerged in the 70 wt% HNO_3 solution at 30° C for 24 hours. The nitric acid experiment setup is shown in Figure 27 below.

Figure 27: Nitric Acid Mass Loss Experiment Setup

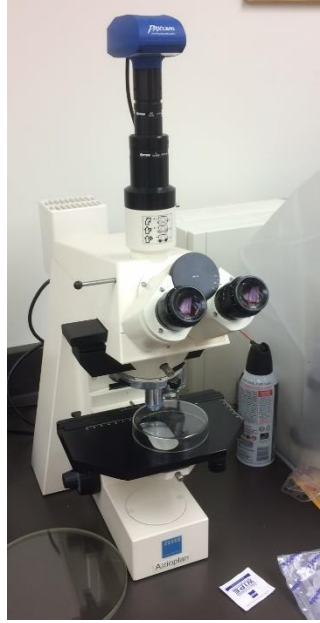
Figure 29: Zeiss Axioplan Optical Microscope and Paxcam 5 Digital Camera

After SEM analysis, the samples were etched as stated above and mounted in a Zeiss Axioplan optical microscope. The samples were then analyzed with a Paxcam 5 digital camera and Pax-it! software at 10x, 20x, and 50x magnification. Figure 29 below refers.
